Test Report.

Report No.: **TR 1986766_A**
Creation date **2019-05-29**

Order content	Test of two paint systems
Test item/Sample	zinc spray layers
Date of order	2016-07-20
Samples submitted on	2016-07-20
Order number	-
Testing period	2016-07-22 to 2016-10-24
Editor	Joachim Ströber, T. +49 911 655 5707

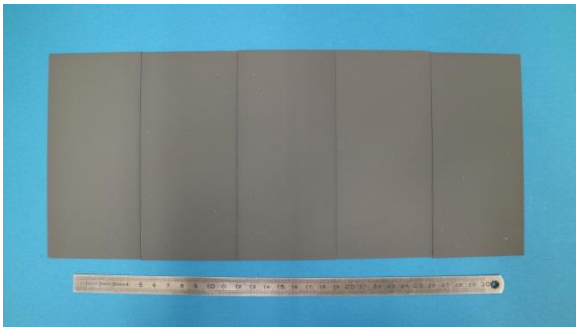
Picture 1
Coated sample plates

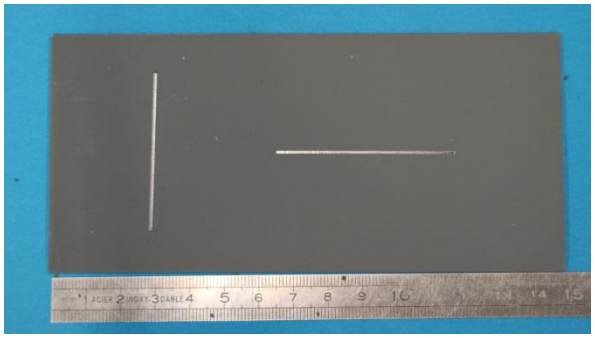
Picture 1
Coated sample plate with scribes

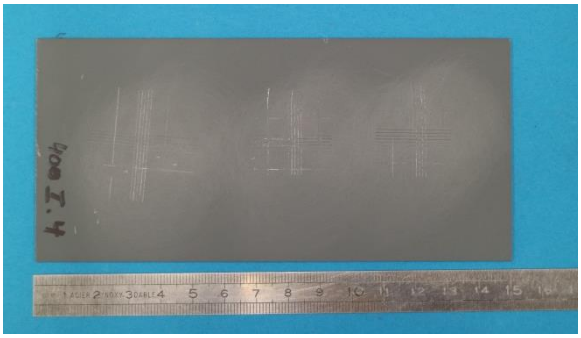
Picture 2
Specimen plate after cross cut test 1mm

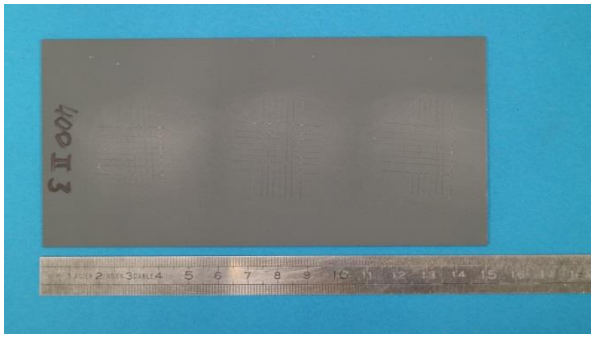
Picture 3
Specimen plate after cross cut test 2mm

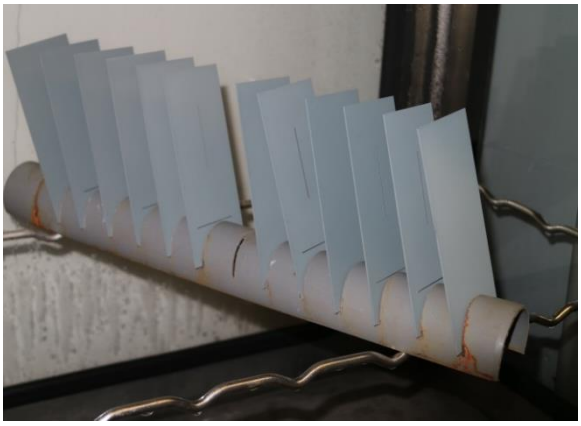
Picture 4
Storage of the samples in the condensation water test

The coated sheets were subjected to a condensation water test in accordance with DIN EN ISO 6270-2 CH (test temperature 40 °C and a humidity of 100%) for a period of 2000 hours. Components with uninjured surfaces and components with Sikken's pre-damaged surface were inspected visually at regular intervals during the course of the test. After completion of the test, an evaluation was carried out.

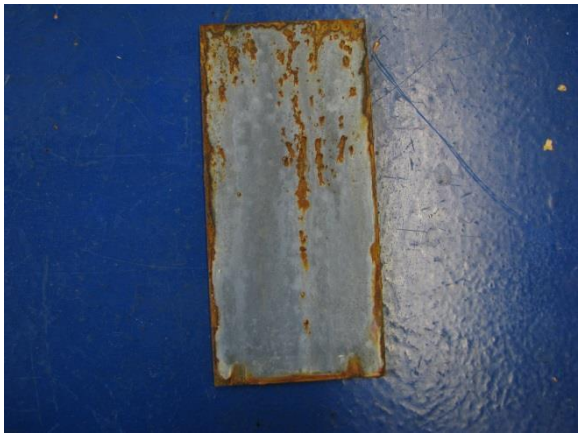
Picture 2
Zinc 240 20-30µm after 720h salt spray test

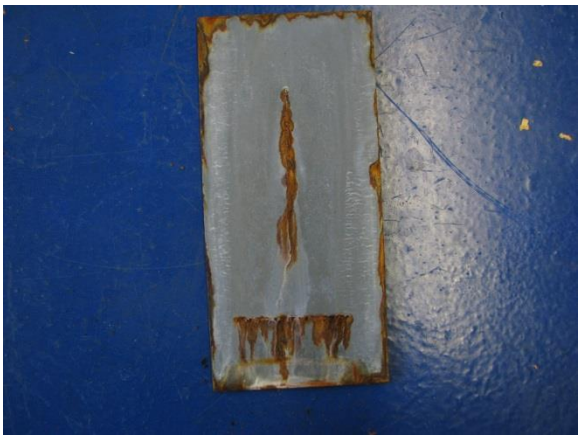
Picture 5
Zinc 240 70-90µm after 720h salt spray test

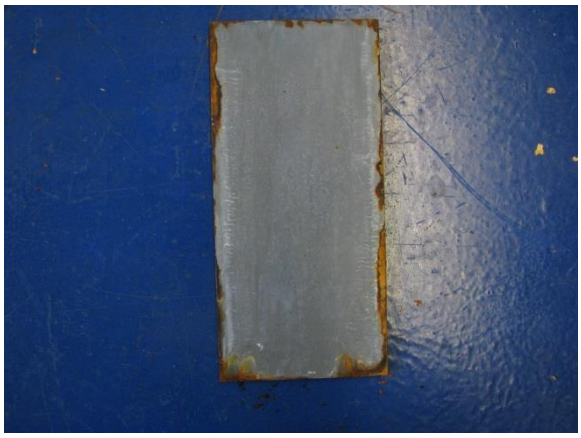
Picture 6
Zinc 240 70-90µm after 720h salt spray test

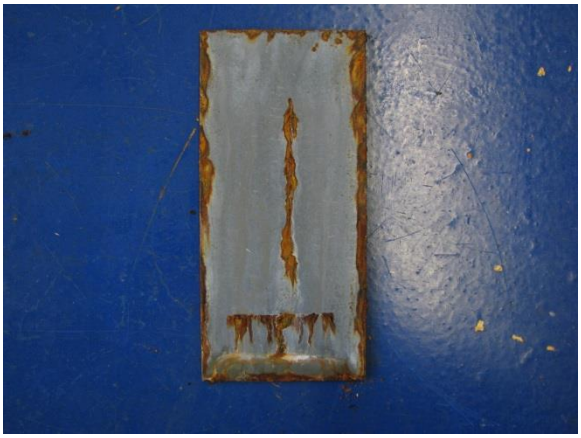
Picture 7
Zinc 720 40-50µm after 720h salt spray test

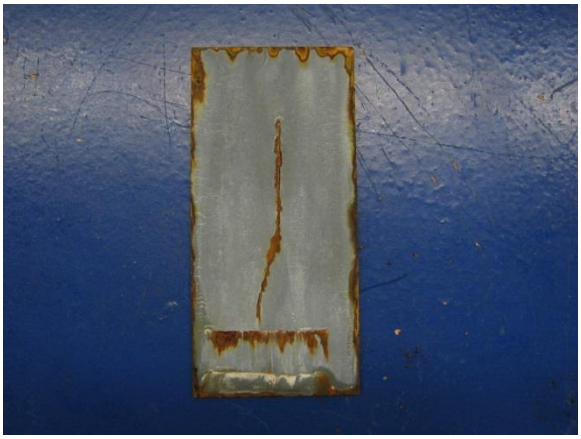
Picture 9
Zinc 720 70-90µm after 720h salt spray test

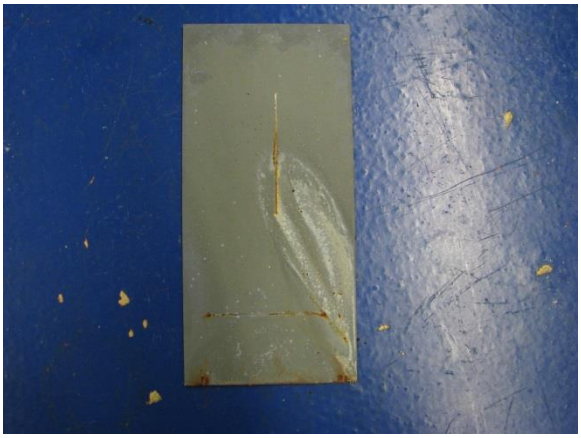
Picture 13
Zinc 240 20-30µm after 2000 h condensation water test

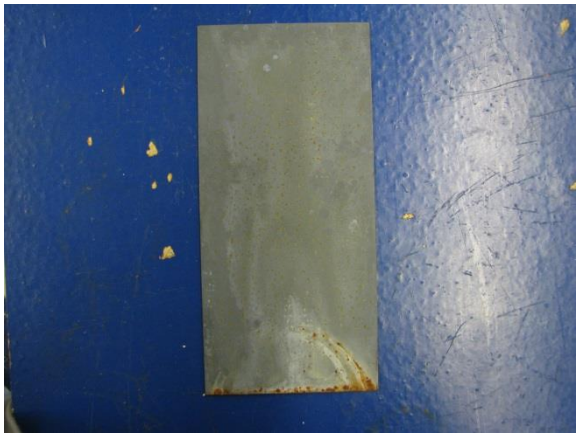
Picture 14
Zinc 240 20-30µm after 2000 h condensation water test

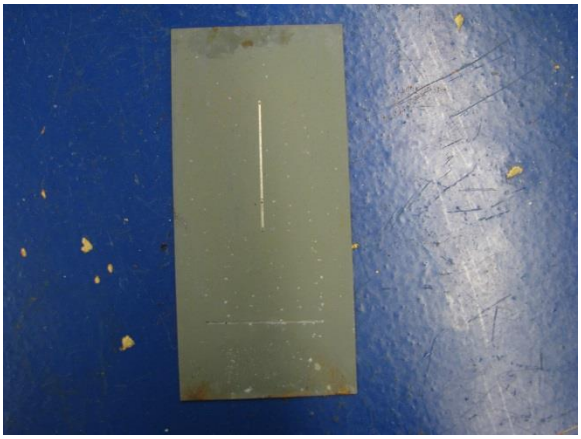
Picture 15
Zinc 240 30-50µm after 2000 h condensation water test

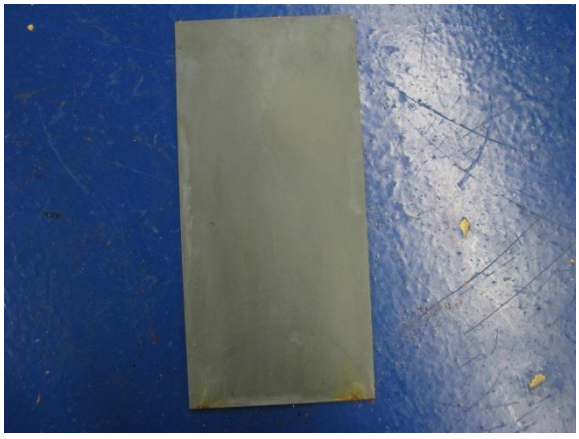
Picture 16
Zinc 240 30-50µm after 2000 h condensation water test

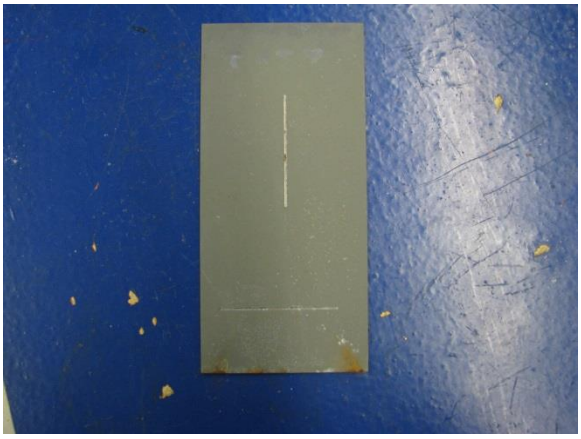
Picture 17
Zinc 240 70-90µm after 2000 h condensation water test

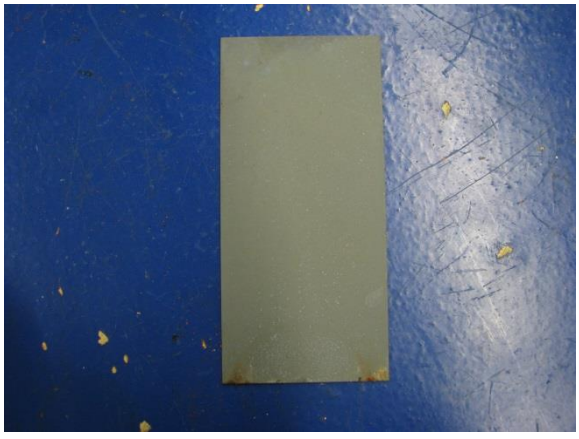
Picture 18
Zinc 240 70-90µm after 2000 h condensation water test

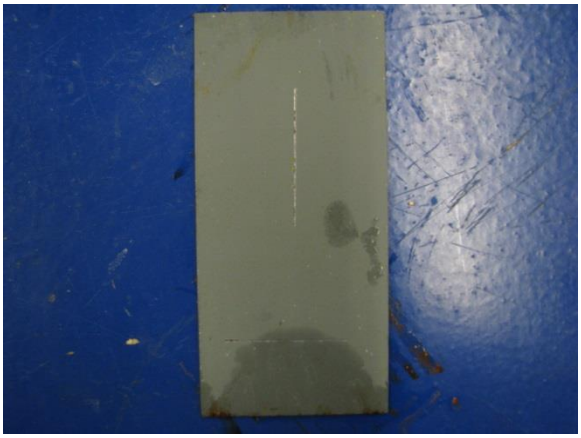
Picture 19
Zinc 720 40-50µm after 2000 h condensation water test

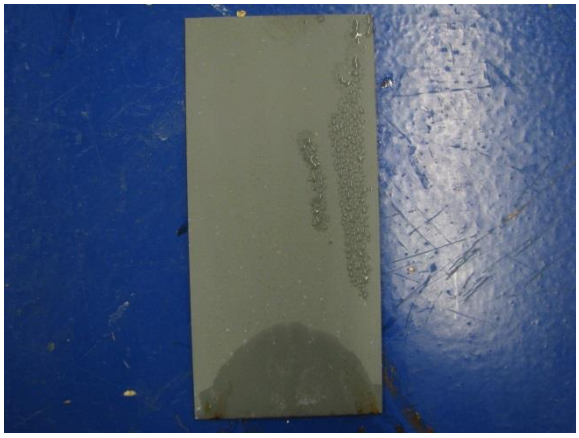
Picture 20
Zinc 720 40-50µm after 2000 h condensation water test

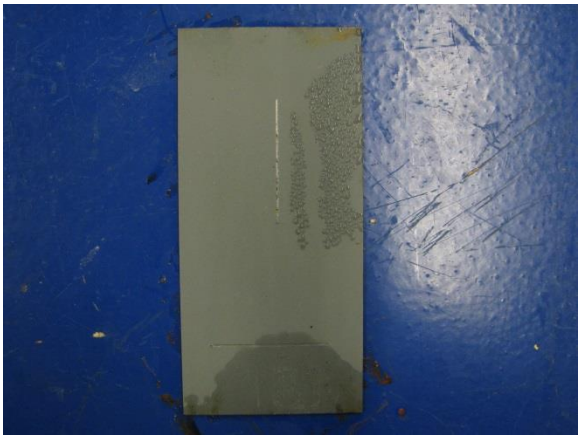
Picture 21
Zinc 720 70-90µm after 2000 h condensation water test

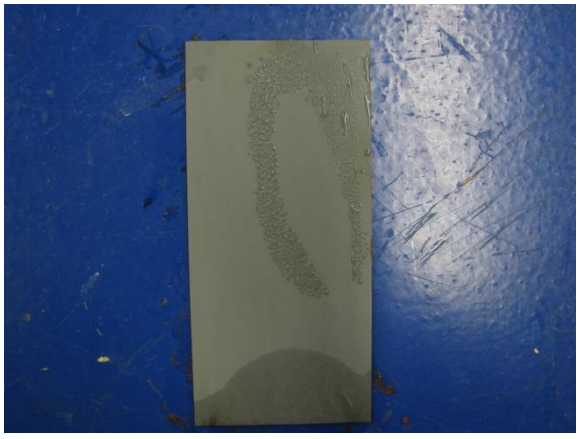
Picture 22
Zinc 720 70-90µm after 2000 h condensation water test

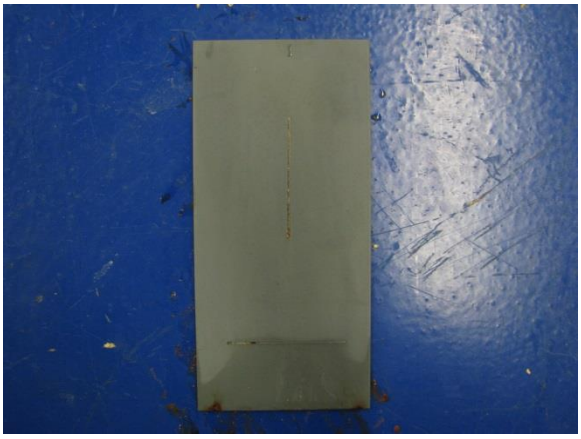
Picture 23
Zinc 720 100-130µm after 2000 h condensation water test

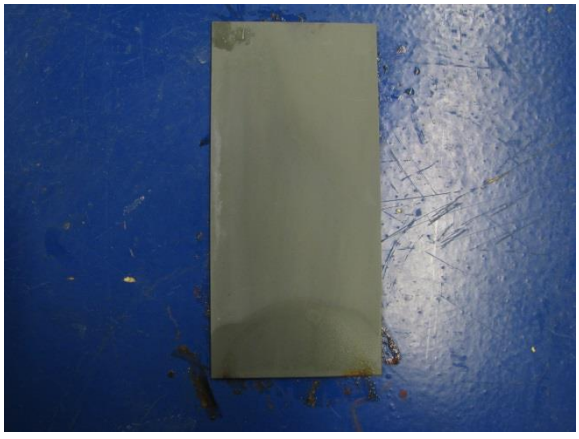
Picture 24
Zinc 720 100-130µm after 2000 h condensation water test
